ERDC/CHL TR-00-3

First Powerhouse, Bonneville Dam, Columbia River, Oregon Report 1, Proposed Trash Holding System

Hydraulic Model Investigation

April 2000

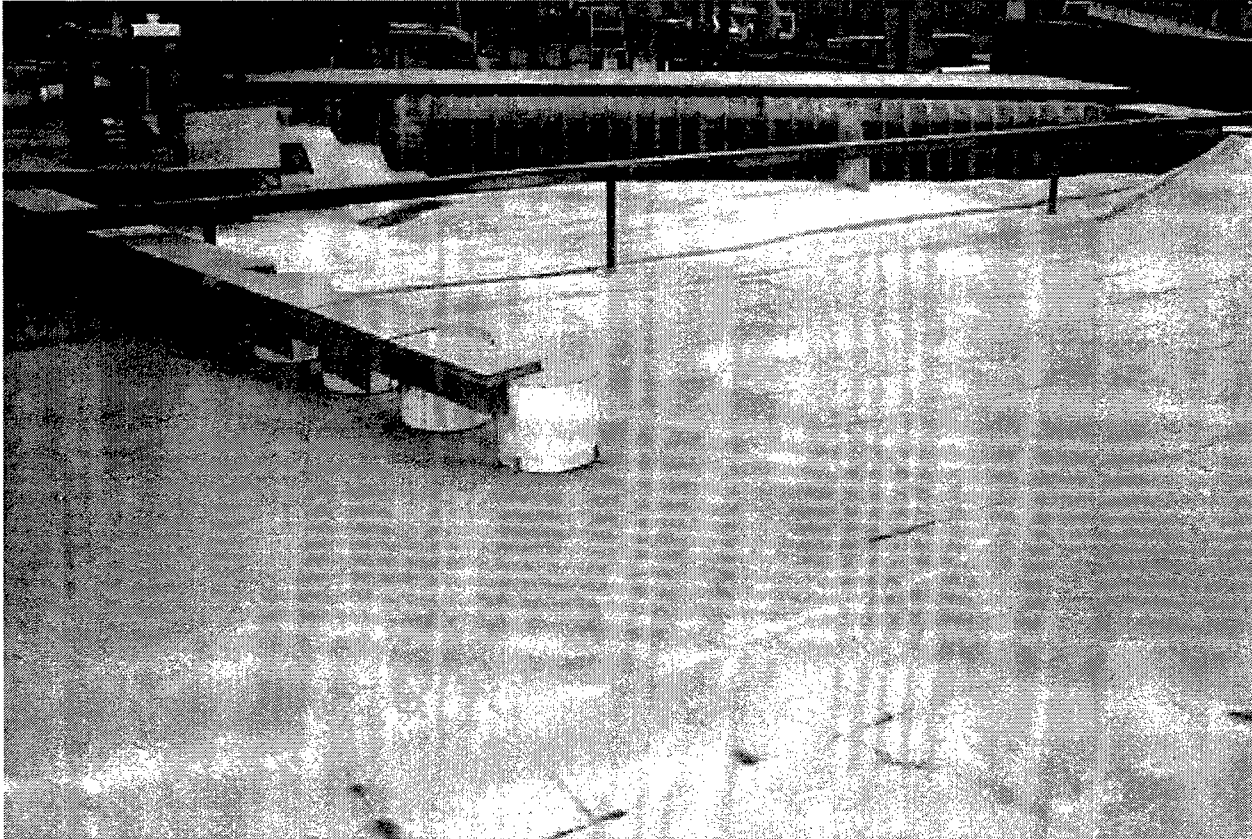
Figure 3. General view of model looking downstream

A 1:40-scale model of the Bonneville First Powerhouse was constructed in 1995 (Figure 3). All 10 powerhouse units were reproduced from acrylic, including the ice and trash sluiceway and the juvenile bypass channel. Approximately 487.68 m (1,600 ft) of approach topography was also reproduced. The U.S. Army Engineer District, Portland, supplied topographical plots, which were transferred into an electronic format. This information was then used to produce templates, which were set to grade in the approach steel flume that had been fabricated for this model. Concrete was poured and smoothed between the templates. The upstream portions of the new and old navigation locks were reproduced from plastic-coated plywood. In addition, submerged traveling screens and vertical barrier screens were reproduced from brass and installed in the model.

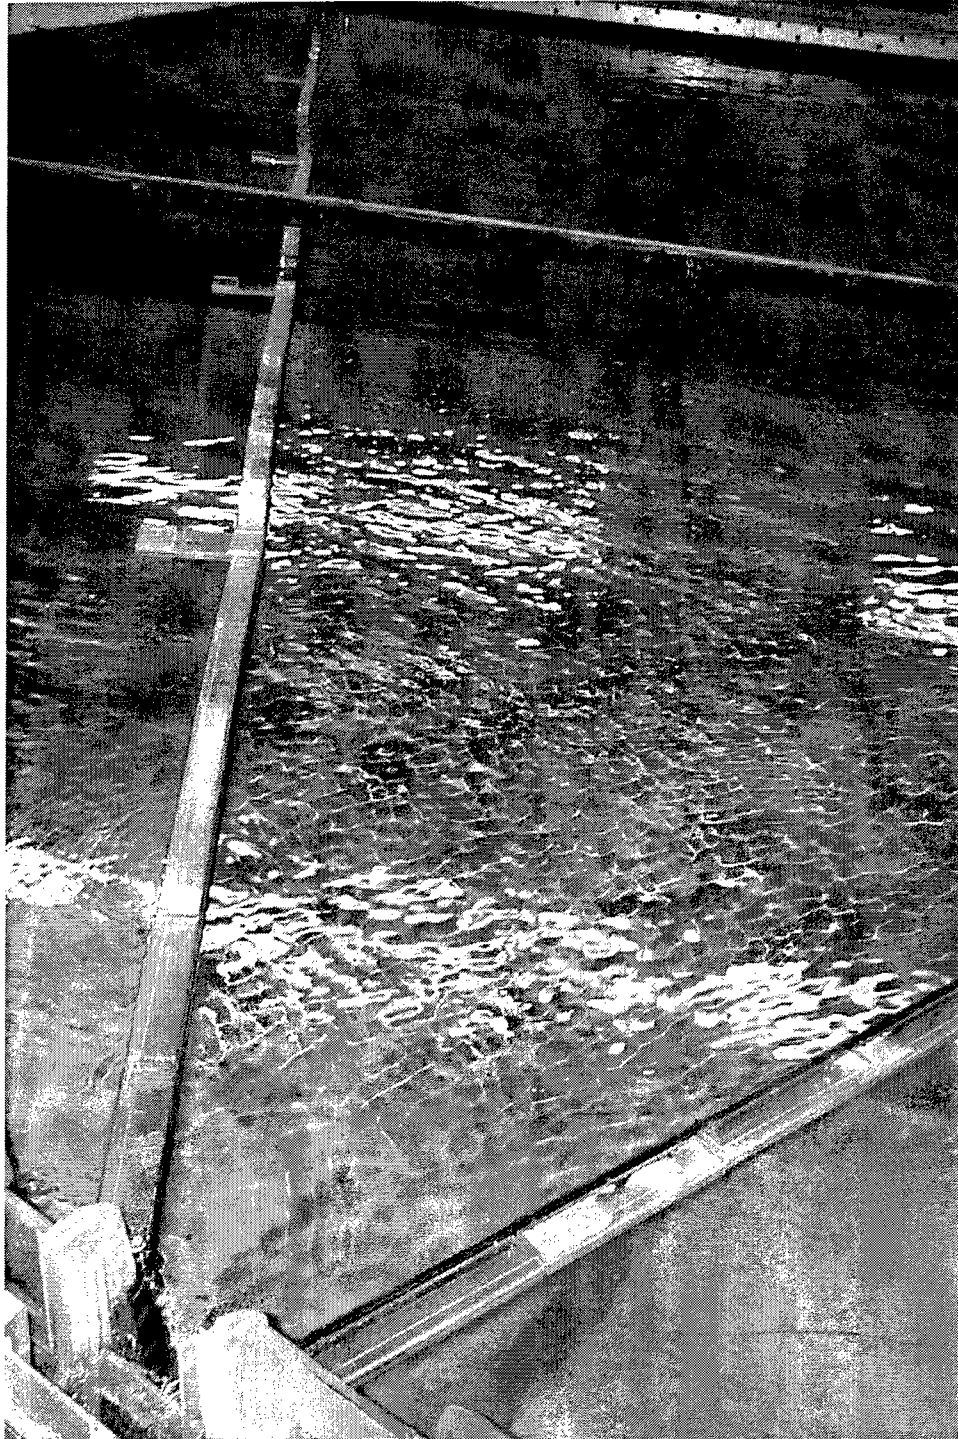
Figure 8. Original trash boom assembly installed in model

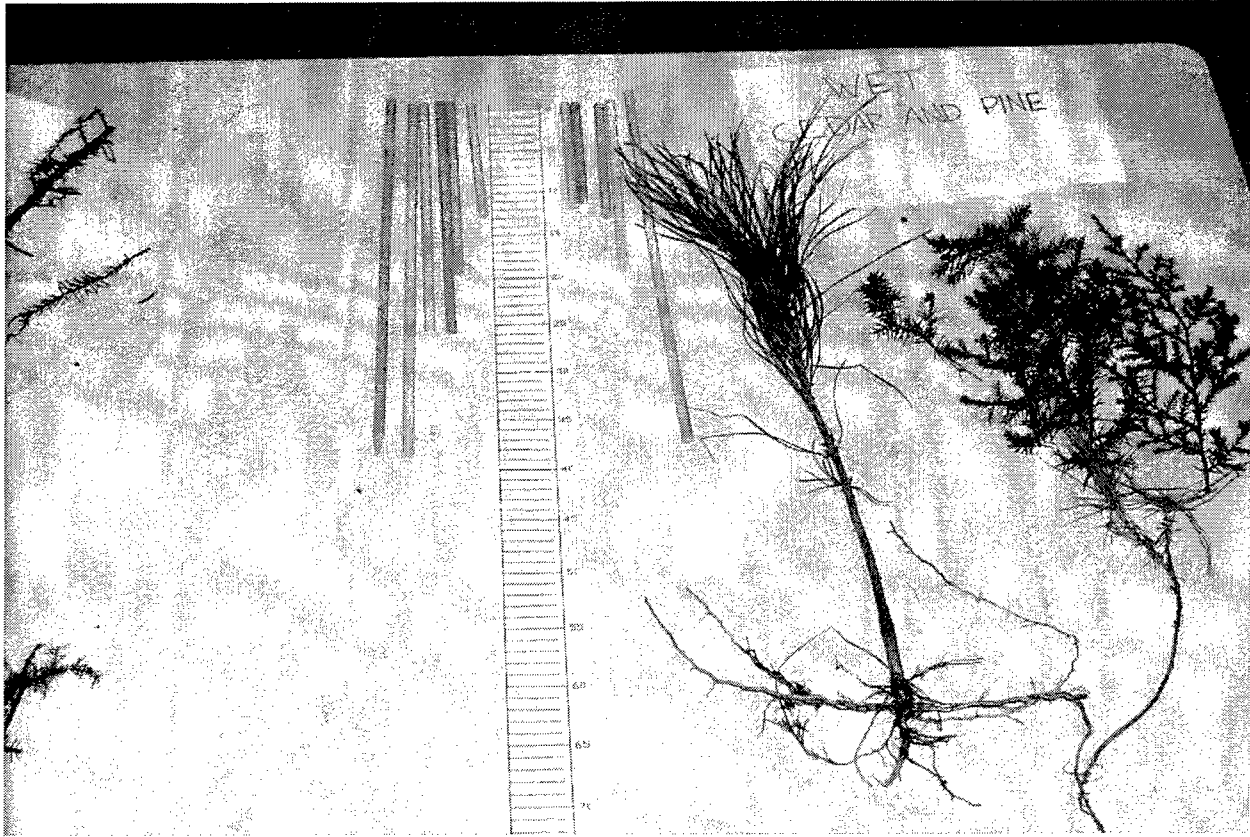
Figure 10. Wet cedar, pine debris, and dowel debris

Debris used during this study consisted of wet and dry branchy cedar, pine needles, dry and wet wooden dowels corresponding to a 0.3048-m- (1-ft-) diameter tree in lengths of 3.810 - 18.288 m (12.5 - 60 ft), plastic that simulated ice, and the root systems of sapling cedar trees (Figures 10 - 12). All debris was cut to sizes that would be expected at the prototype structure. During later experiments wooden dowels simulating 1.0668-m- (3.5-ft-) diameter debris were also used.

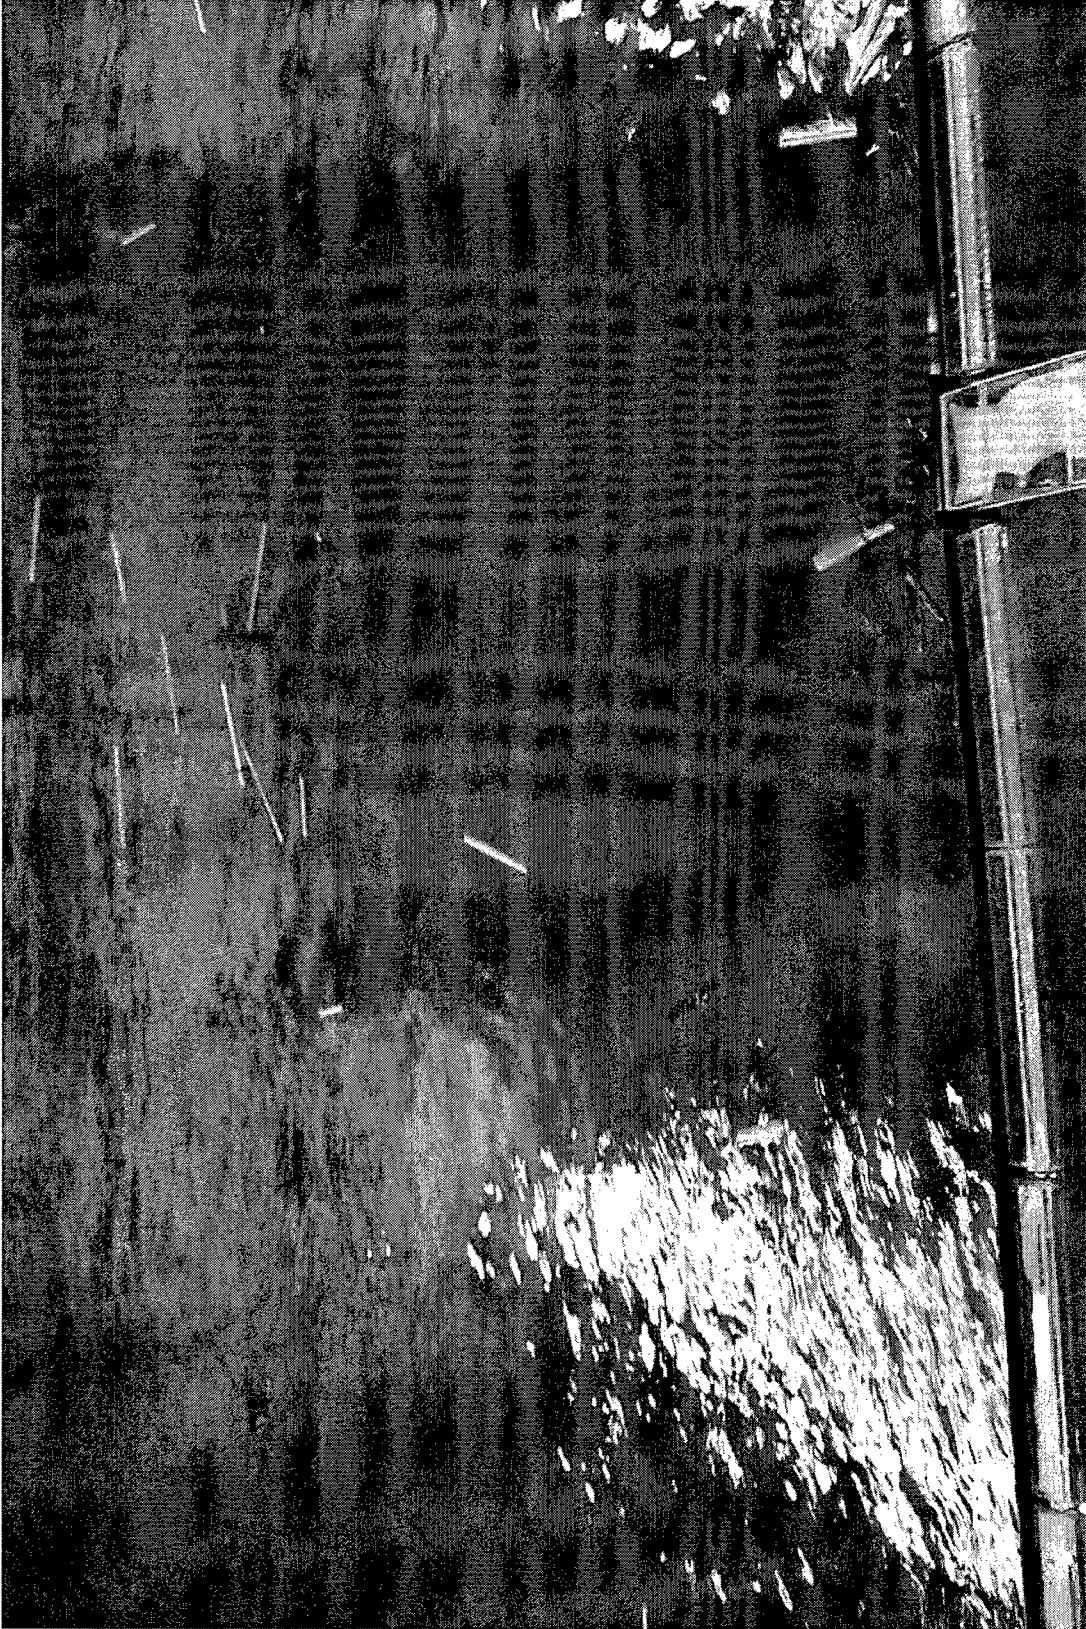
Photo 2. Debris along trash boom; original boom alignment; discharge per unit 297.339 cu m/sec (10,500 cfs); pool el 77.0

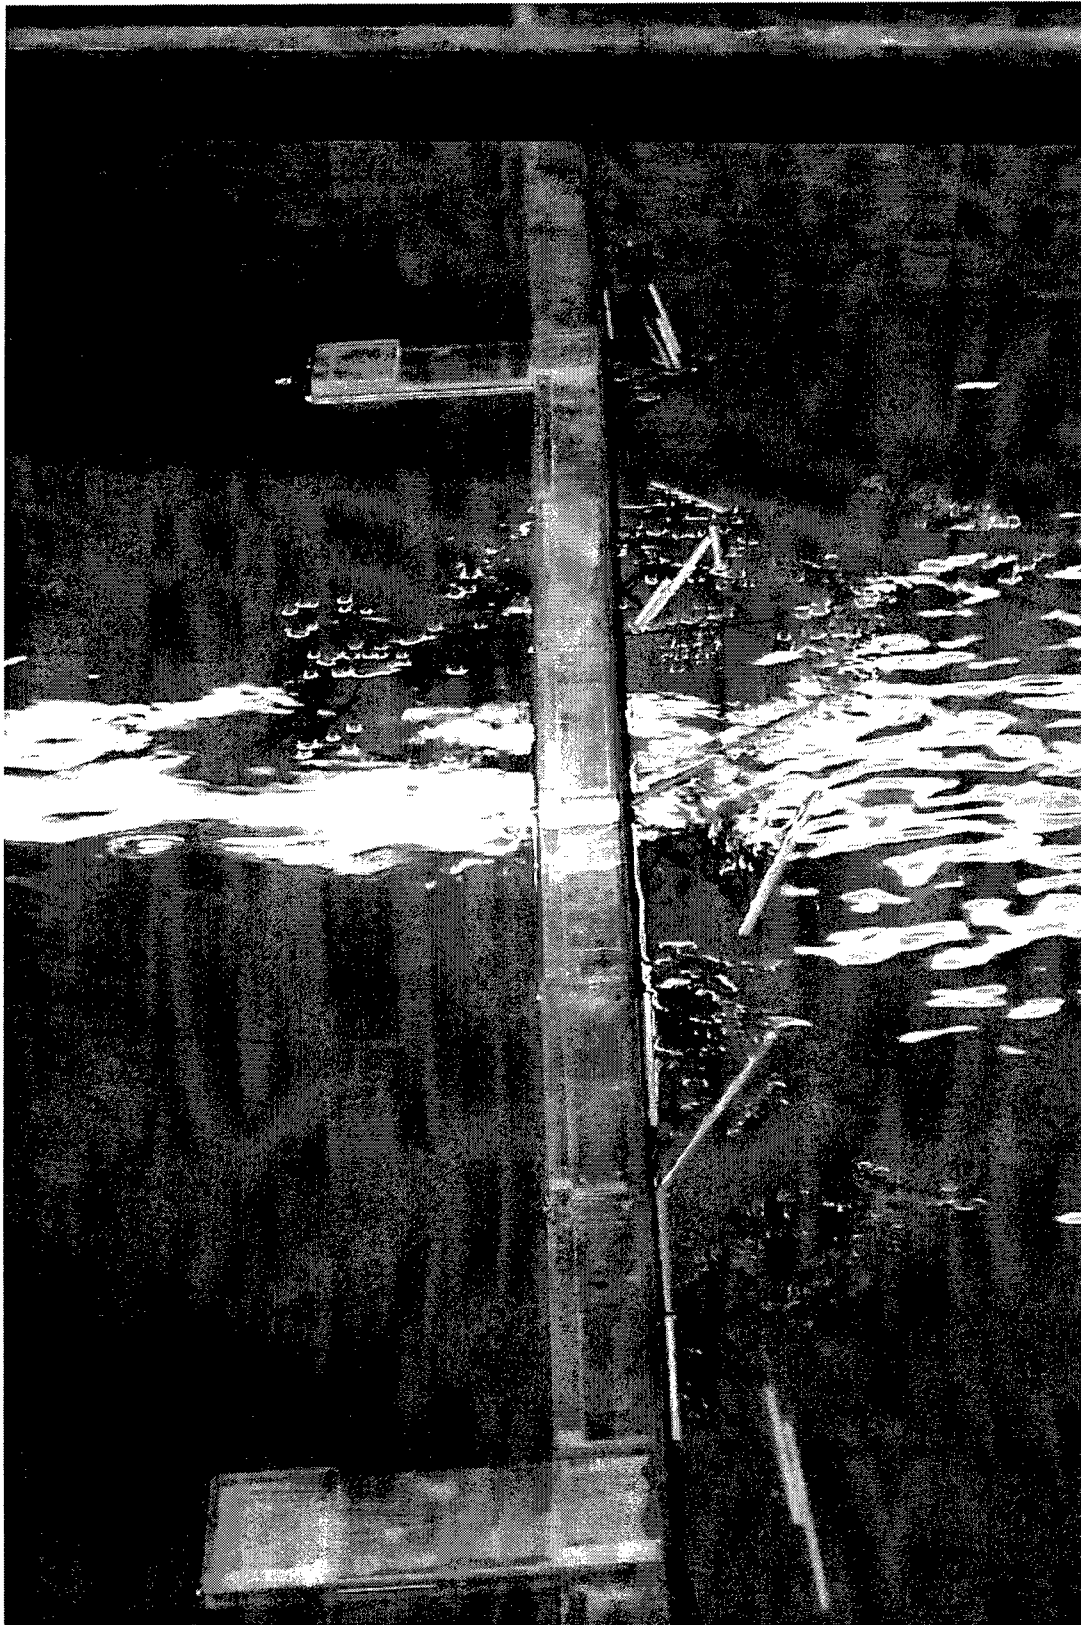
Photo 3. Wet debris passing under trash boom; original boom alignment; discharge per unit 297.339 cu m/sec (10,500 cfs); pool el 77.0

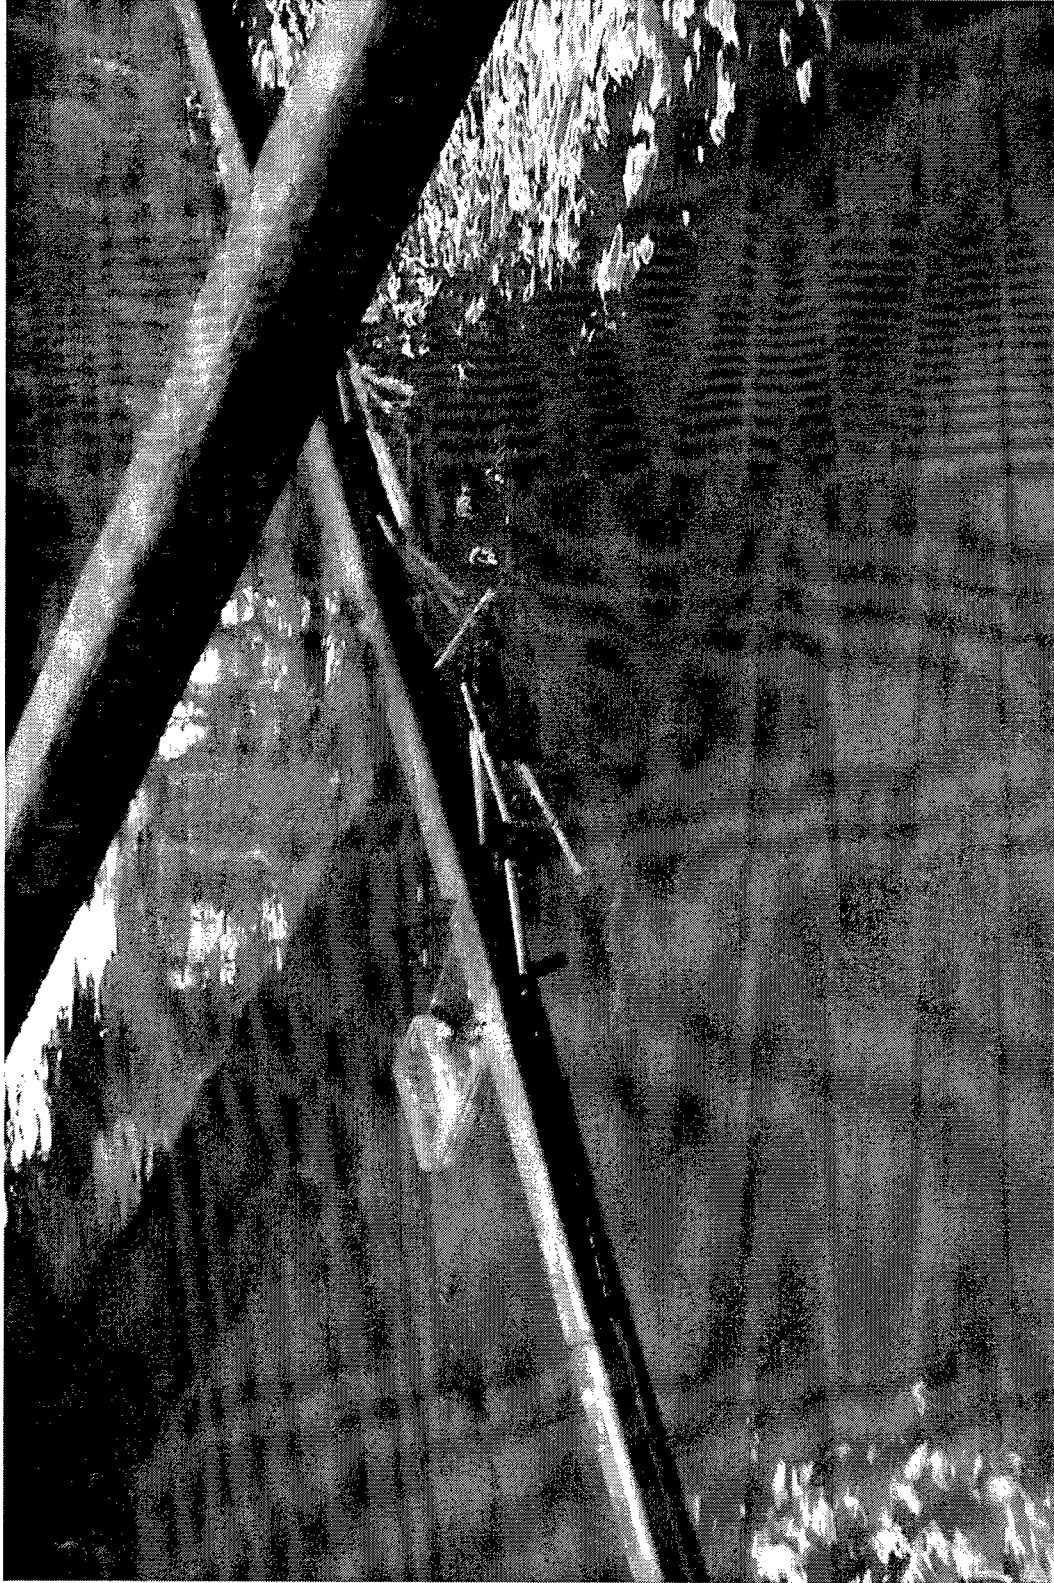
Photo 26. Various debris moving along trash boom; original boom alignment; discharge per unit 382.293 cu m/sec (13,500 cfs); pool el 71.5

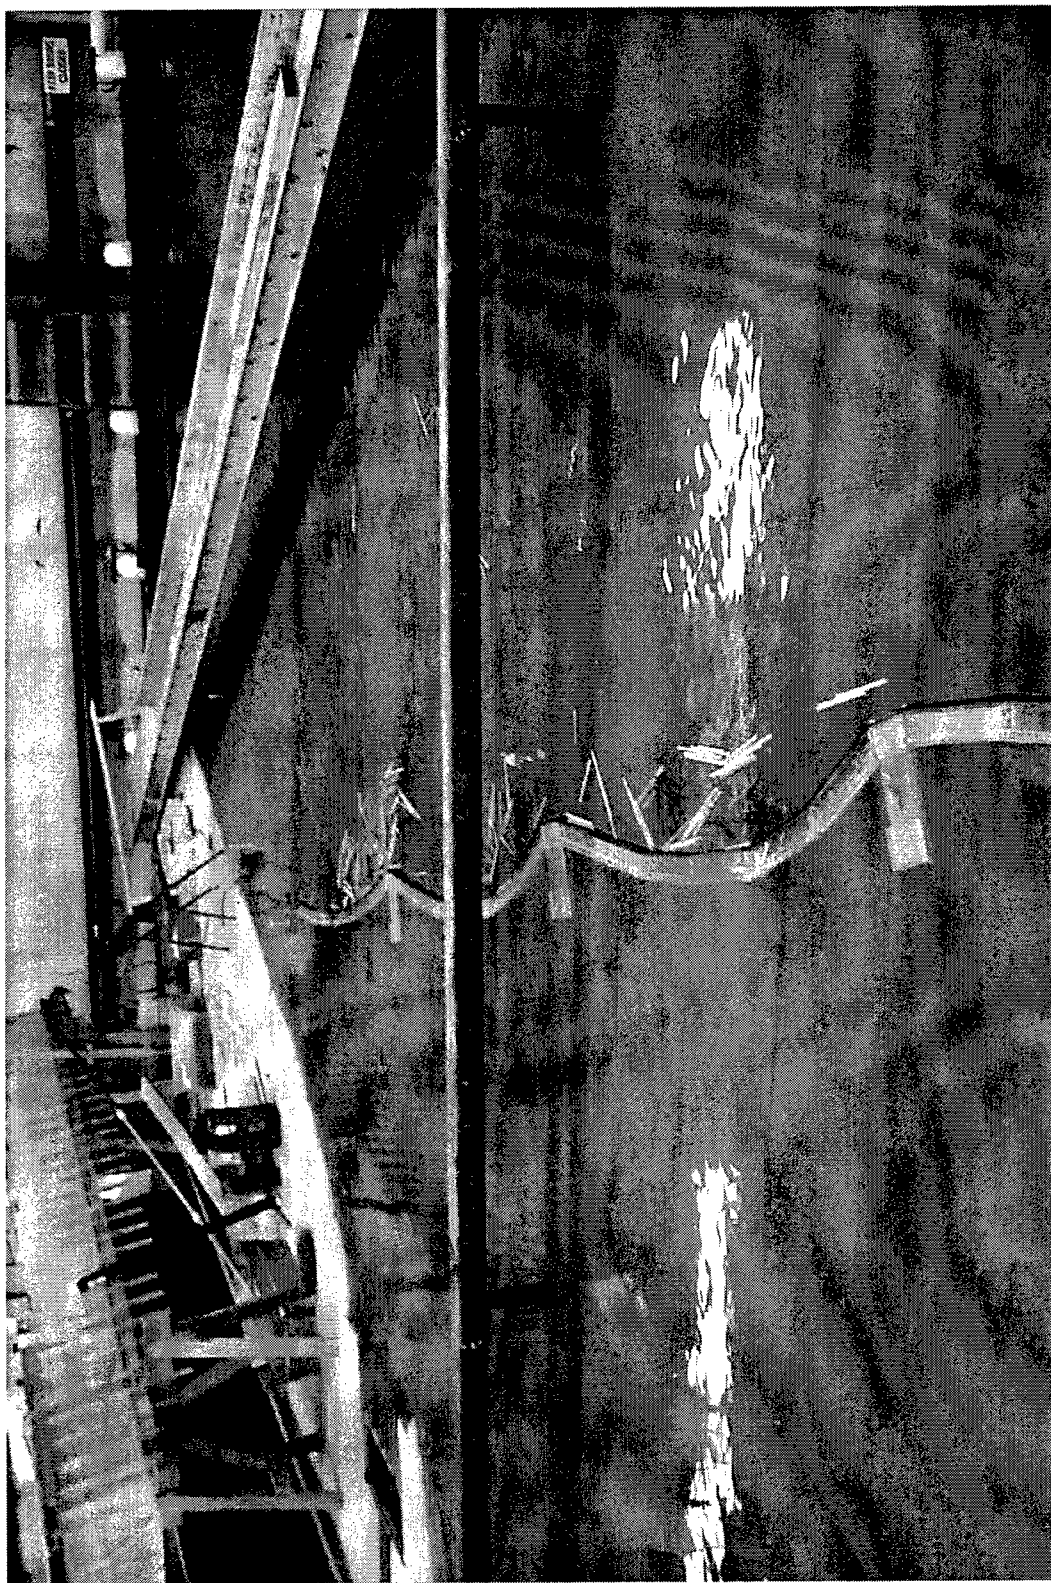
Photo 33. Debris collecting along the trash boom; final boom alignment; discharge per unit 297.339 cu m/ sec (10,500 cfs); pool el 74.5

Each of the 10 powerhouse units was set with a discharge of 297.339 cu m/sec (10,500 cfs) and the upper pool was set at el 74.5. All sluiceway gates were closed except for Unit 0, which was open to el 68.0. Wooden dowels were added to the model upstream of the boat entrance and just downstream of the upper limits of the model. These dowels had lengths ranging from 18.288 m (60 ft) (prototype) to a minimum length of 1.8288 m (6 ft). These dowels were introduced together and separately. All dowels moved along the trash boom to the Unit 0 entrance. None of the 18.288-m (60-ft) (Photo 32) or 12.192-m (40-ft) dowels passed into the ice and trash sluiceway. Some of the 10.0584-m (33-ft) dowels were caught in the ice and trash sluiceway and caused the smaller dowels to become lodged around them. However, without the 10.0584-m (33-ft) dowels in the debris mixture, all the dowels passed through the ice and trash sluiceway. Also a few of the 8.2296-m (27-ft) dowels hung between the two trash booms in the Unit 0 ice entrance when placed in the model by themselves. The wedge piece that was added downstream of the entrance of Unit 0 improved the passage of debris through the ice and trash sluiceway. Also, various lengths of 1.0668-m (3.5-ft) diameter dowels were put into the model and allowed to progress along the boom. Dowels smaller than 8.2296 m (27 ft) passed through the Unit 0 sluice gate while 8.2296 m (27 ft) and longer did not (Photo 33).

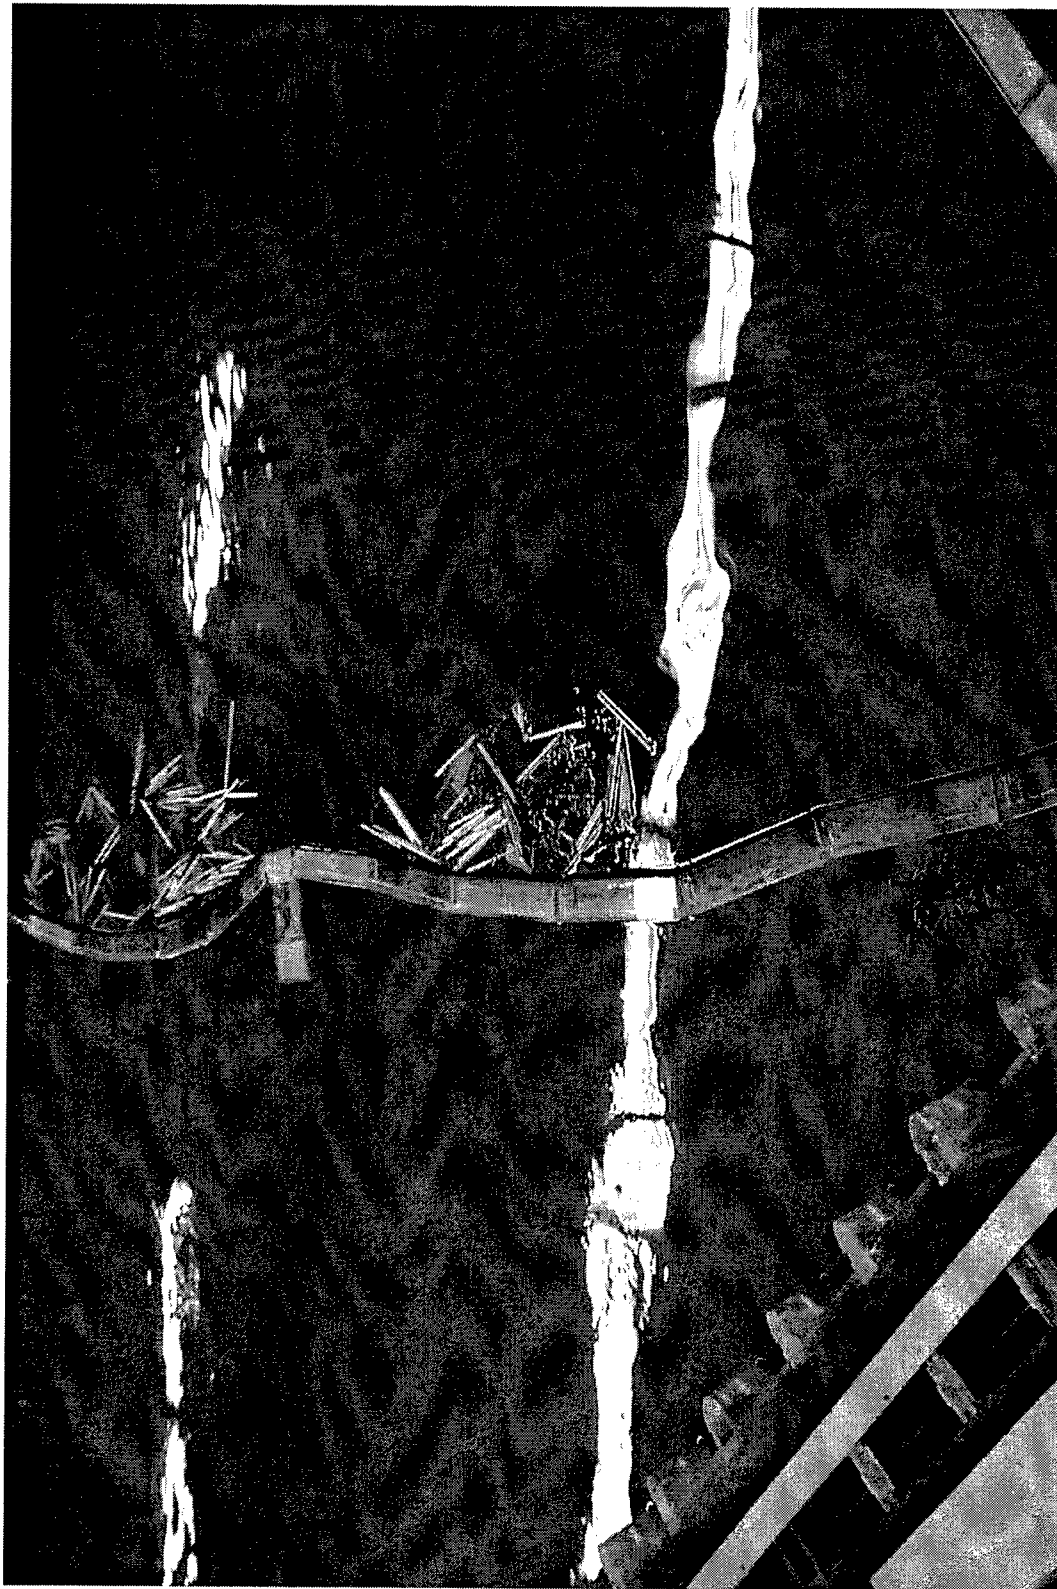
Photo 34. Debris collecting along the trash boom; final boom alignment; discharge per unit 297.339 cu m/sec (10,500 cfs); pool el 74.5

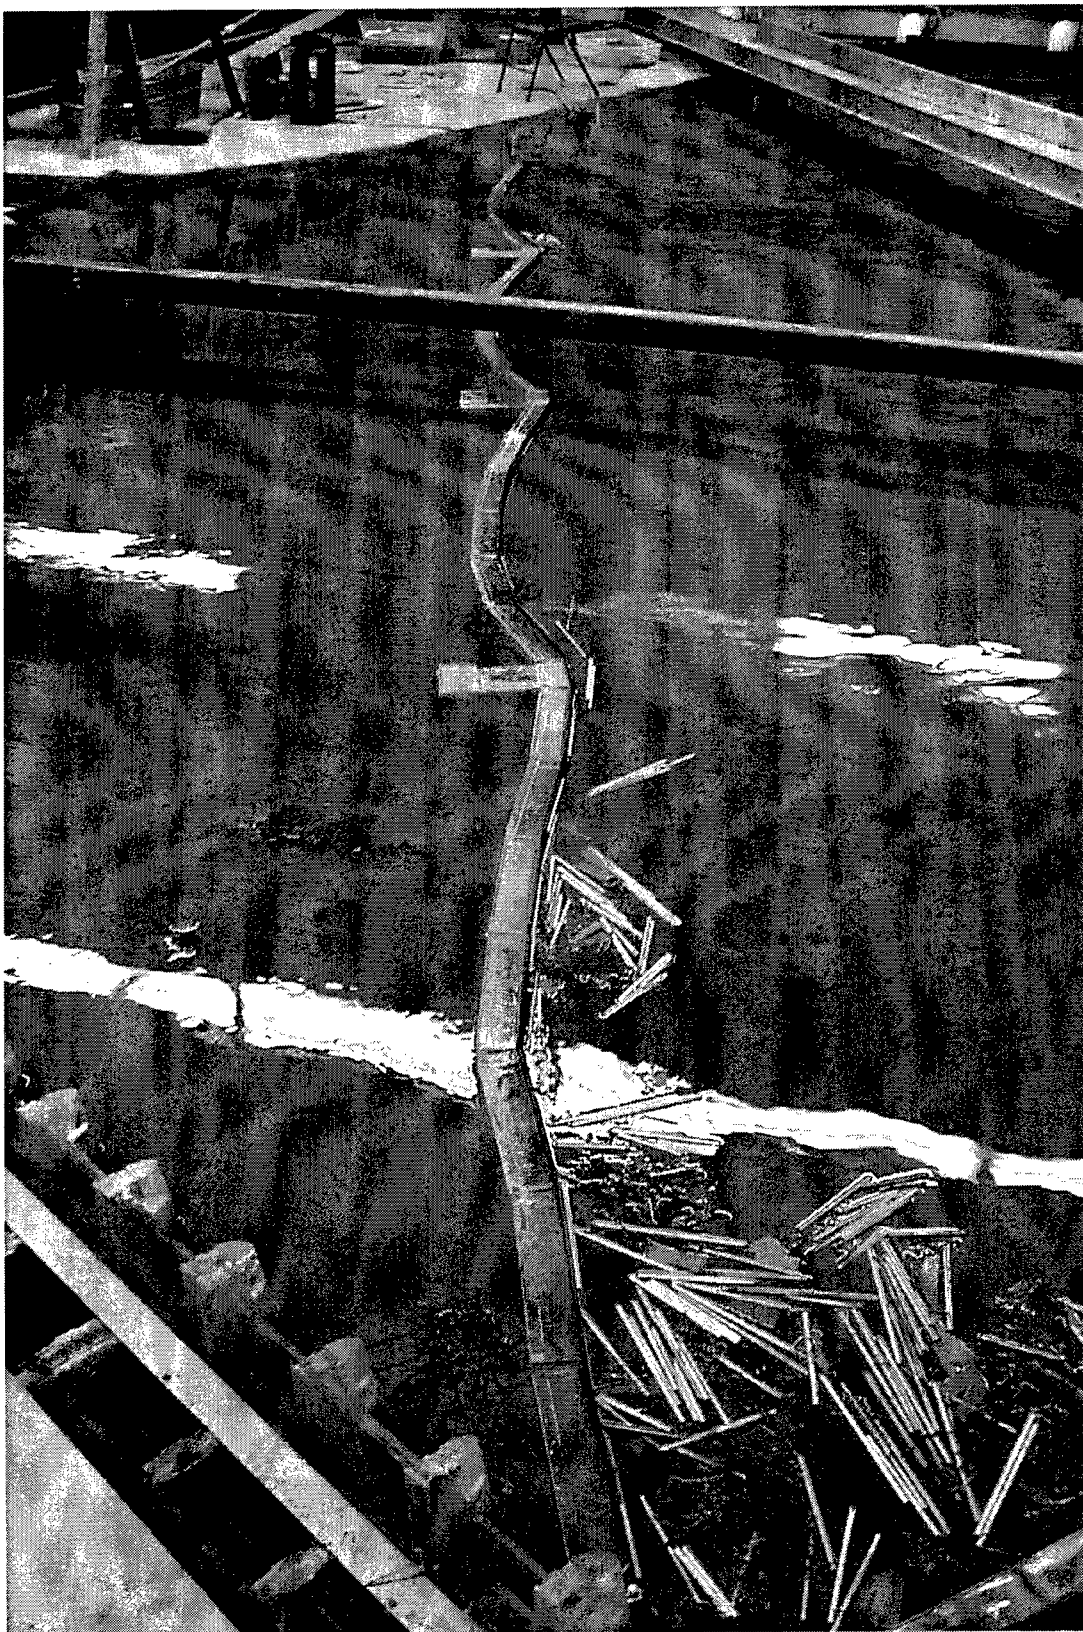
Photo 35. Debris at powerhouse Unit 1 and in Unit 0 sluiceway entrance; final boom alignment; discharge per unit 297.339 cu m/sec (10,500 cfs); pool el 74.5
